The Effects of Aerial Hydromulch on Hillslope Erosion and Plant Recovery Following Wildfire in Chaparral Shrublands

K. R. Hubbert¹, R. Colter², and J. A. Johnson³

¹ Hubbert & Associates, ² El Dorado National Forest, ³ San Bernardino National Forest

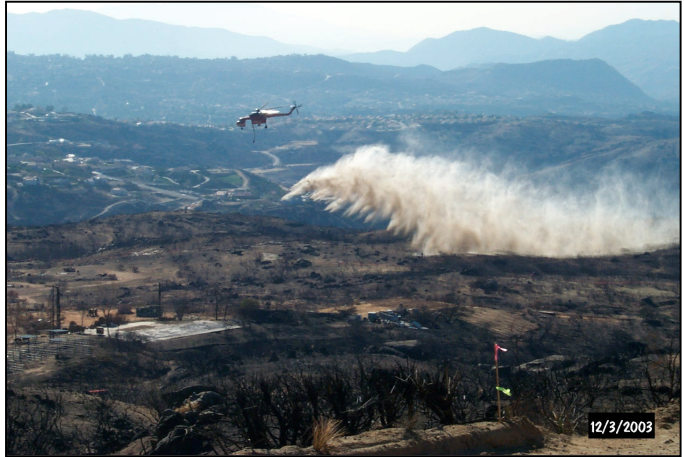
Hydromulch was applied in 30 m wide strips for the “50% treatment”. On the surface, the hydromulch tended to be thicker at the center of the strip, decreasing towards the edges of the strip.

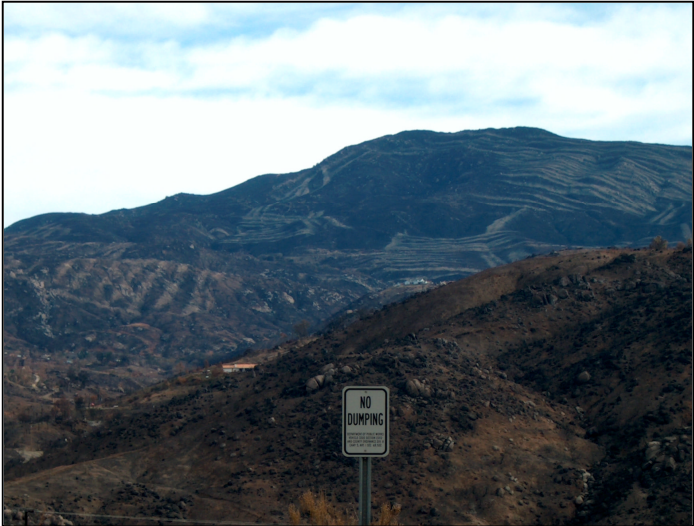
Hydromulch strip treatment applied at 30 m intervals on the contour.

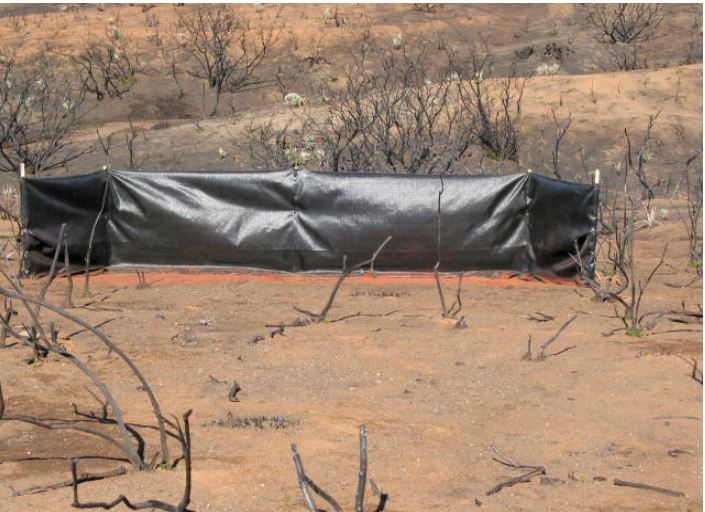
Silt fence construction viewed from contributing area. Note red chalk designating surface boundary.

To monitor hillslope erosion, we installed a total of 54 silt fences at the site. Silt fences were distributed as follows: gabbro control = 13; gabbro strip 50% cover = 11; granitic strip 50% cover = 10; 100% cover granitic = 10, and granitic control = 10.

To locate and place the 1 m² grids, we used the contributing boundaries that extended up from the silt fences for 100 ft on both sides as transects. On the right side looking up from the silt fence, we sampled at 5 m, 15 m, and 25 m. On the left side boundary, we sampled at 10 and 20 m.

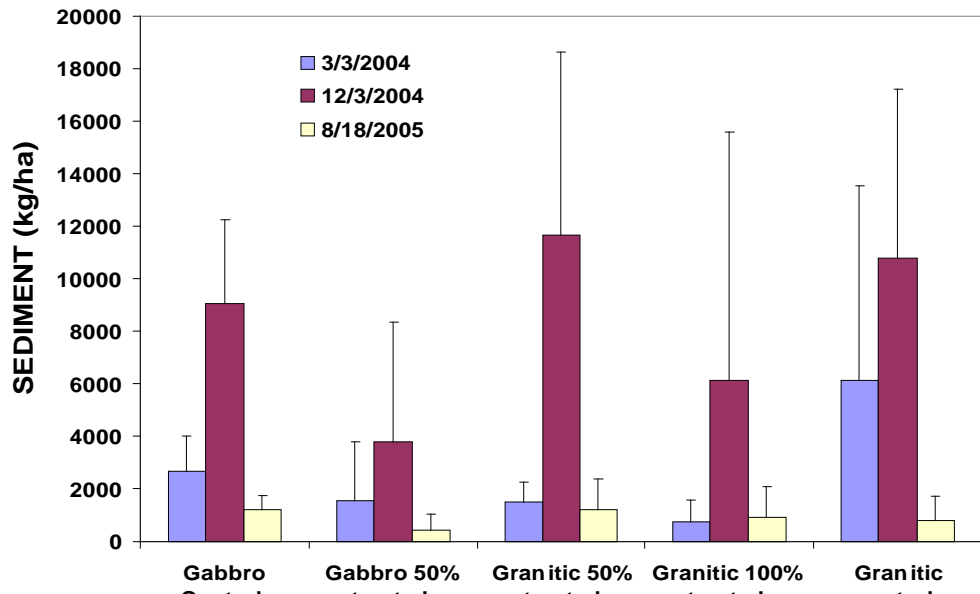
Fig. 1. Sediment production measured at three different time intervals following the fire. Five treatment categories were studied: (1) Gabbro control, (2) Gabbro 50% treated, (3) Granitic 50% treated, (4) Granitic 100% treated, and (5) Granitic control.

On the 3/3/2004 sampling date, it is evident that hydromulch reduced erosion in both the 50% strip and 100% cover treatments. However, the below normal rainfall amounts resulted in erosion totals in the control plots that were well below predicted amounts. It was also assumed that the hydromulch controlled the movement of water by allowing greater infiltration.

After the above normal October rainfall events, far greater hillslope erosion occurred as seen in for the 12/3/2004 sampling date. The 50% hydromulch treatment on the gabbro was effective in decreasing erosion by more than half of what occurred on the control sites. On the granitic sites, the 100% hydromulch treatment was effective in reducing erosion, but erosion on the 50% treated sites was greater than the control. It appeared that the intensity of the rain events toward the end of October was an important factor in determining overland flow, especially when antecedent soil moisture conditions were near or at field capacity.

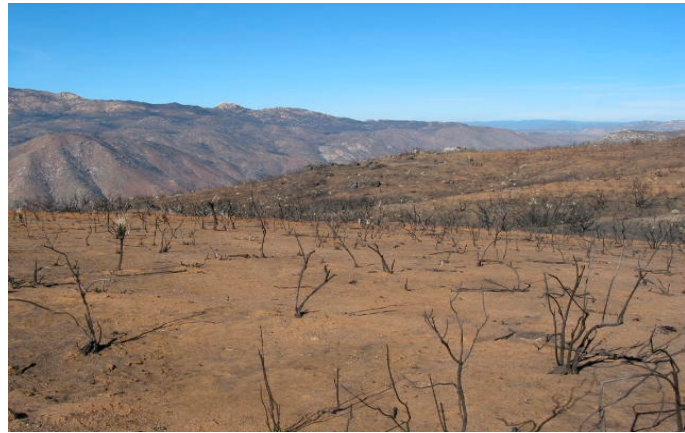
Photo of the burned area underlain by granitic parent material taken in December 2004. There were few signs of vegetation recovery at this time.

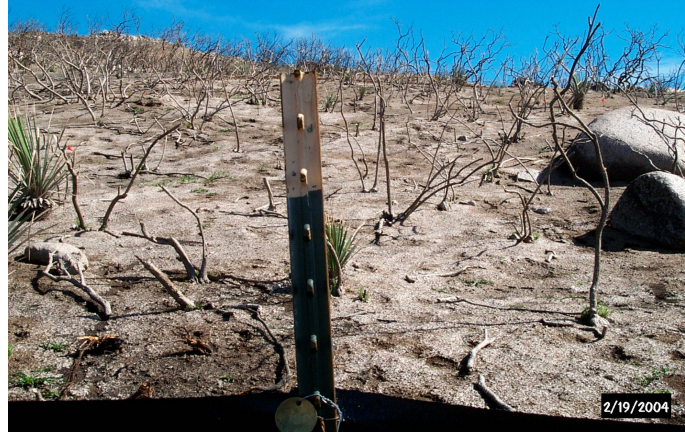
View of contributing area of silt fence 39 (100% treatment-granitic) showing vegetation recovery on 2/19/2004. Chamise skeletons were just beginning to resprout.

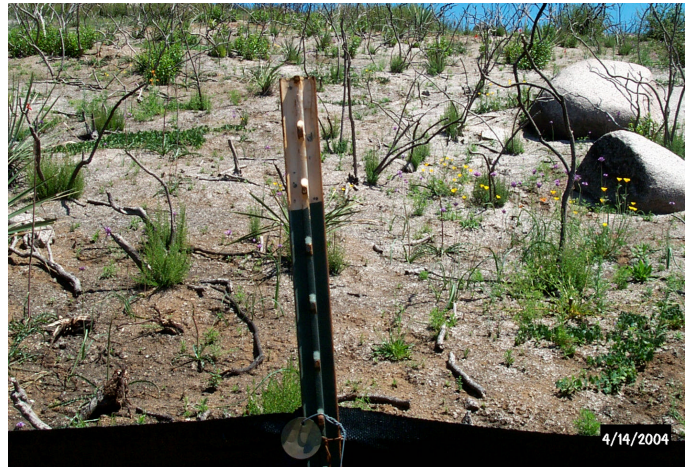
Same view of contributing area of silt fence 39 (100% treatment-granitic) showing vegetation recovery on 4/14/2004. Chamise were vigorously resprouting.

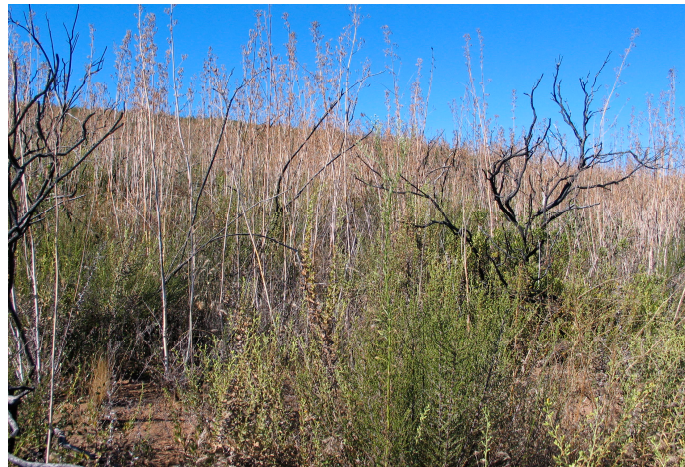
View of site on 8-18-2005. Vegetation cover at this time was 72%.
